Craven District Council

Jerry Croft, Skipton

Road Safety Risk Assessment

Report Ref:	8376/AND/001/01	January 2015	
Author:	Adam Darwin		
Checked & Approved:	David Colley	Date:	12 January 2015

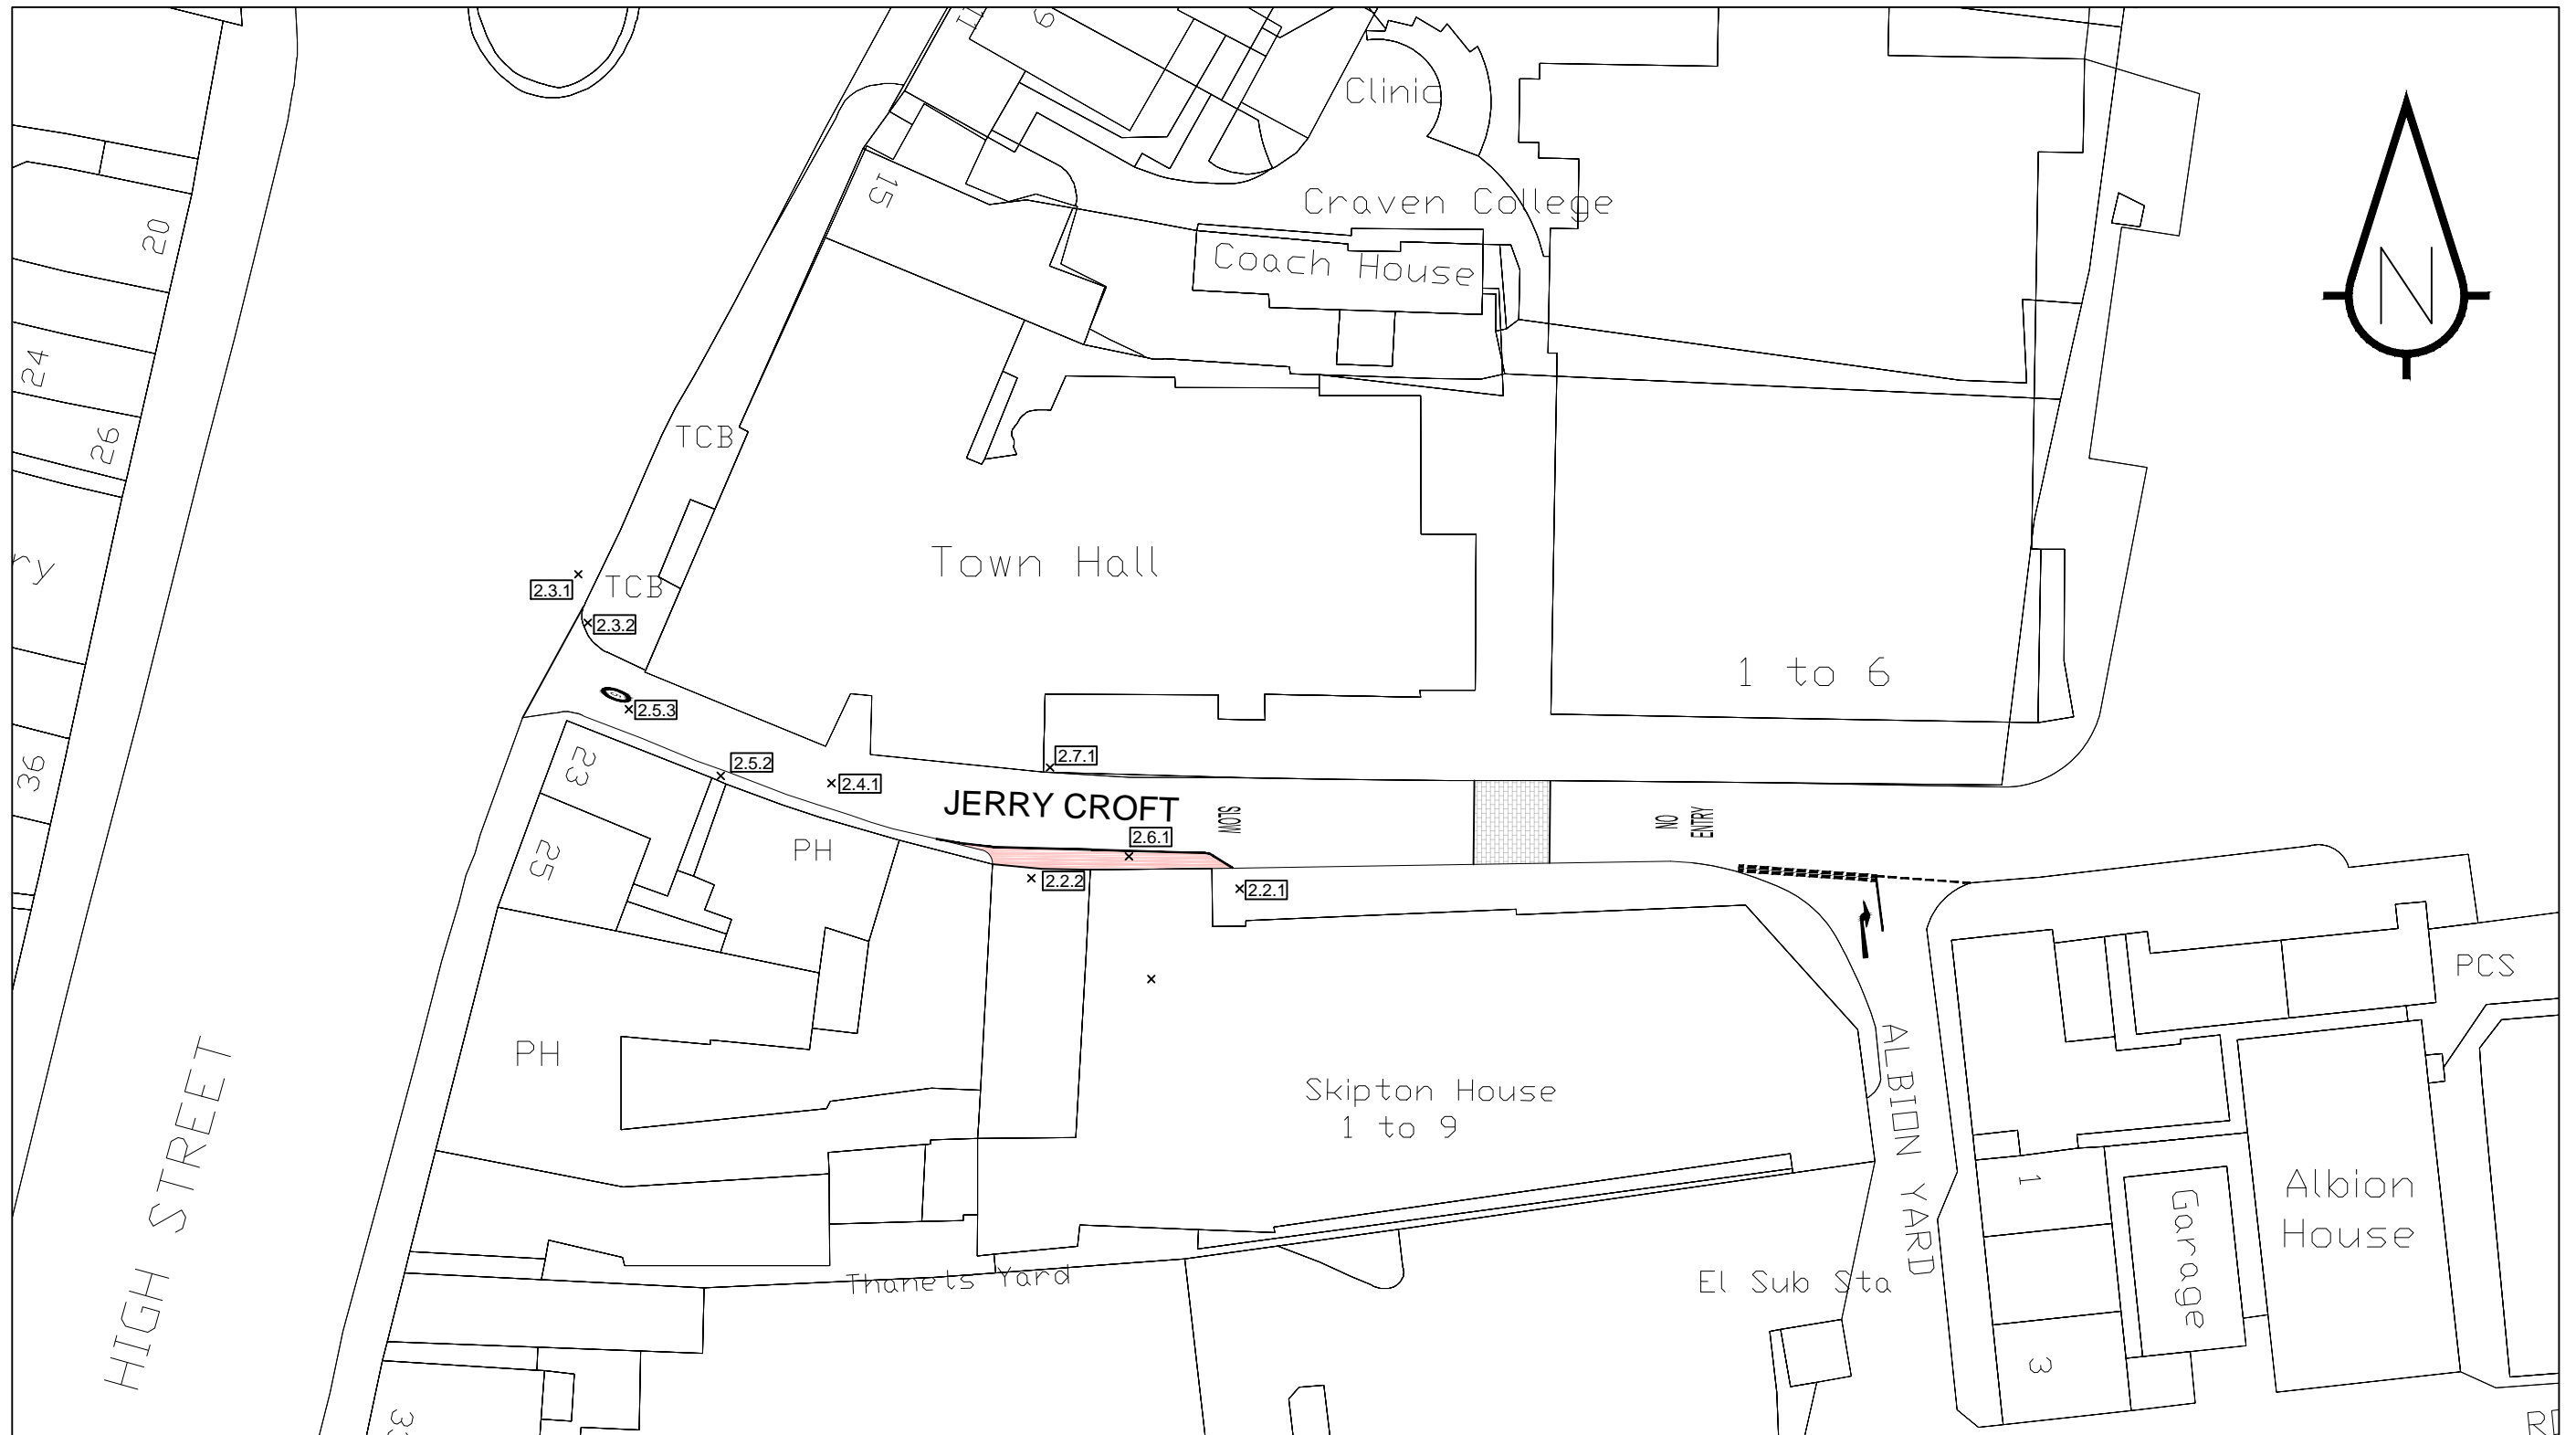
Drawing 8376/001 Problem Location Plan

- 2.1.6 The following sections identify some of the key safety problems that have been identified, with drawing 8376/001 included in **Appendix A** identifying their approximate location. It is noted that general problems or those with multiple locations have not all been shown.
